Site Investigation Report

St George's Barracks
Rutland, UK

January 2018

Prepared for: Rutland County Council

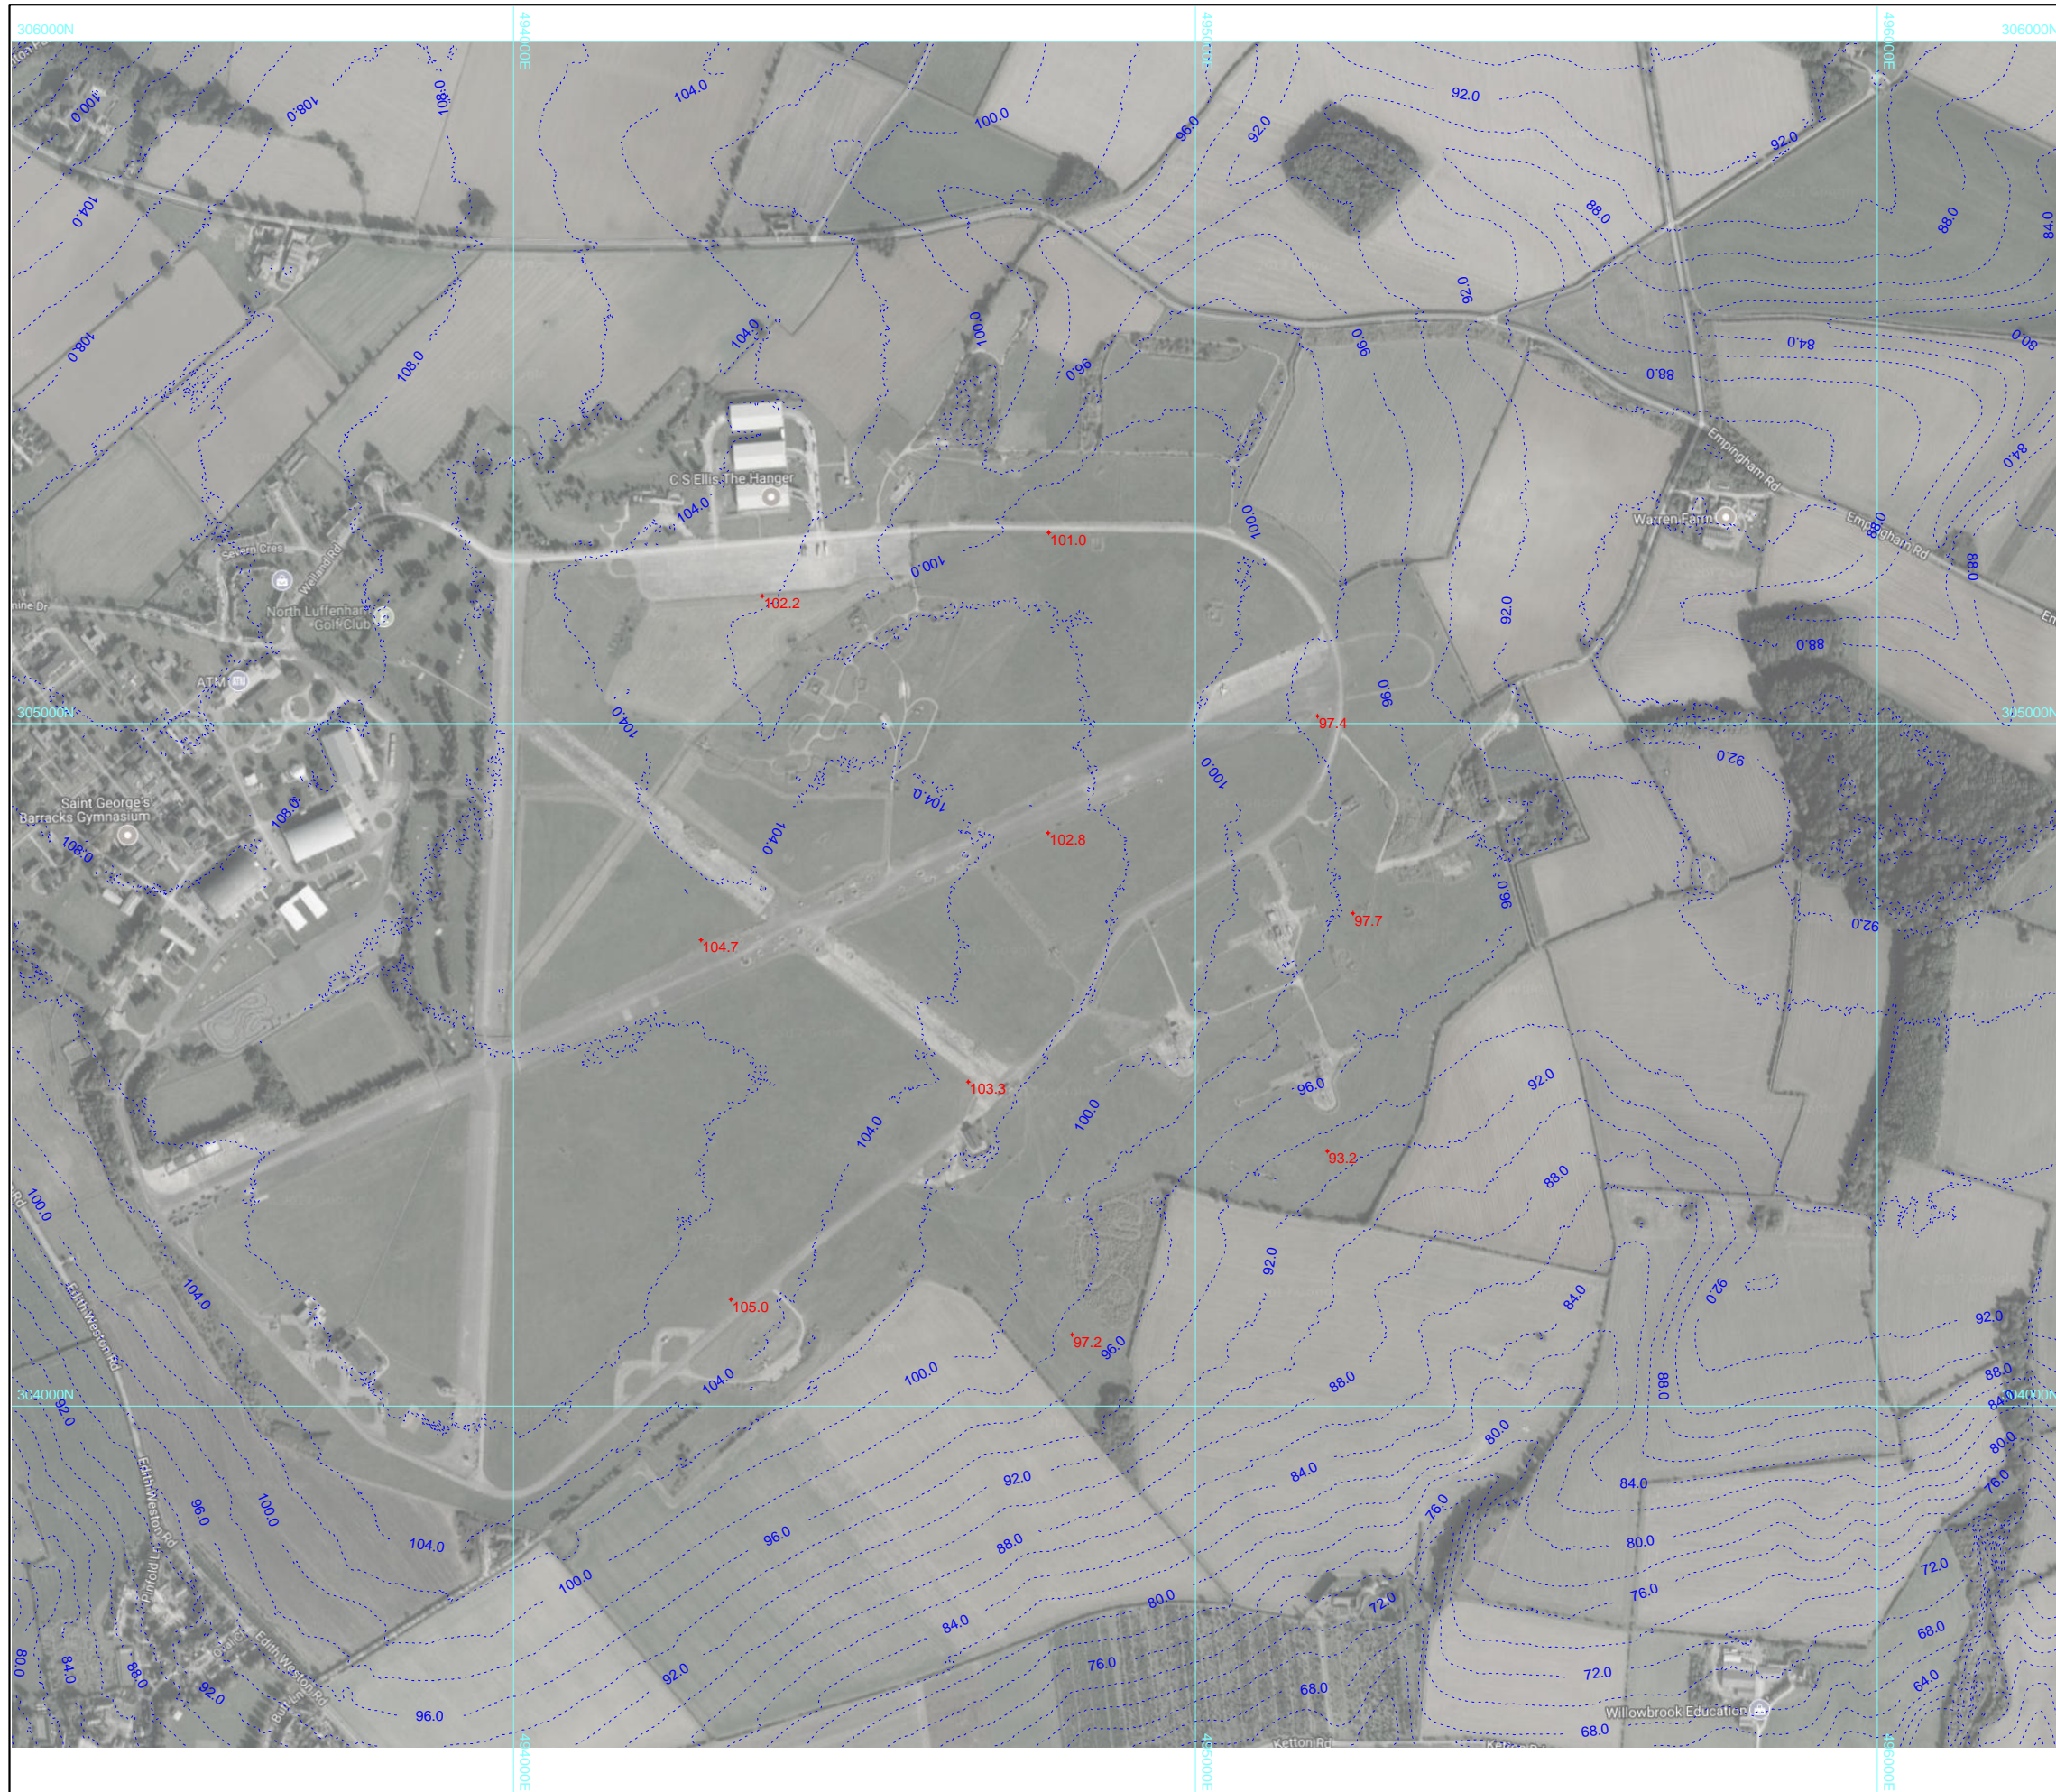
Drawing No:
EG-SGB-TS-0118

Drawing Name:
**Site Topography
 from EA 2m LiDAR DTM**

The topography of the site and immediate surrounds can be seen in plan EG-SGB-TS-1801 in Appendix B.

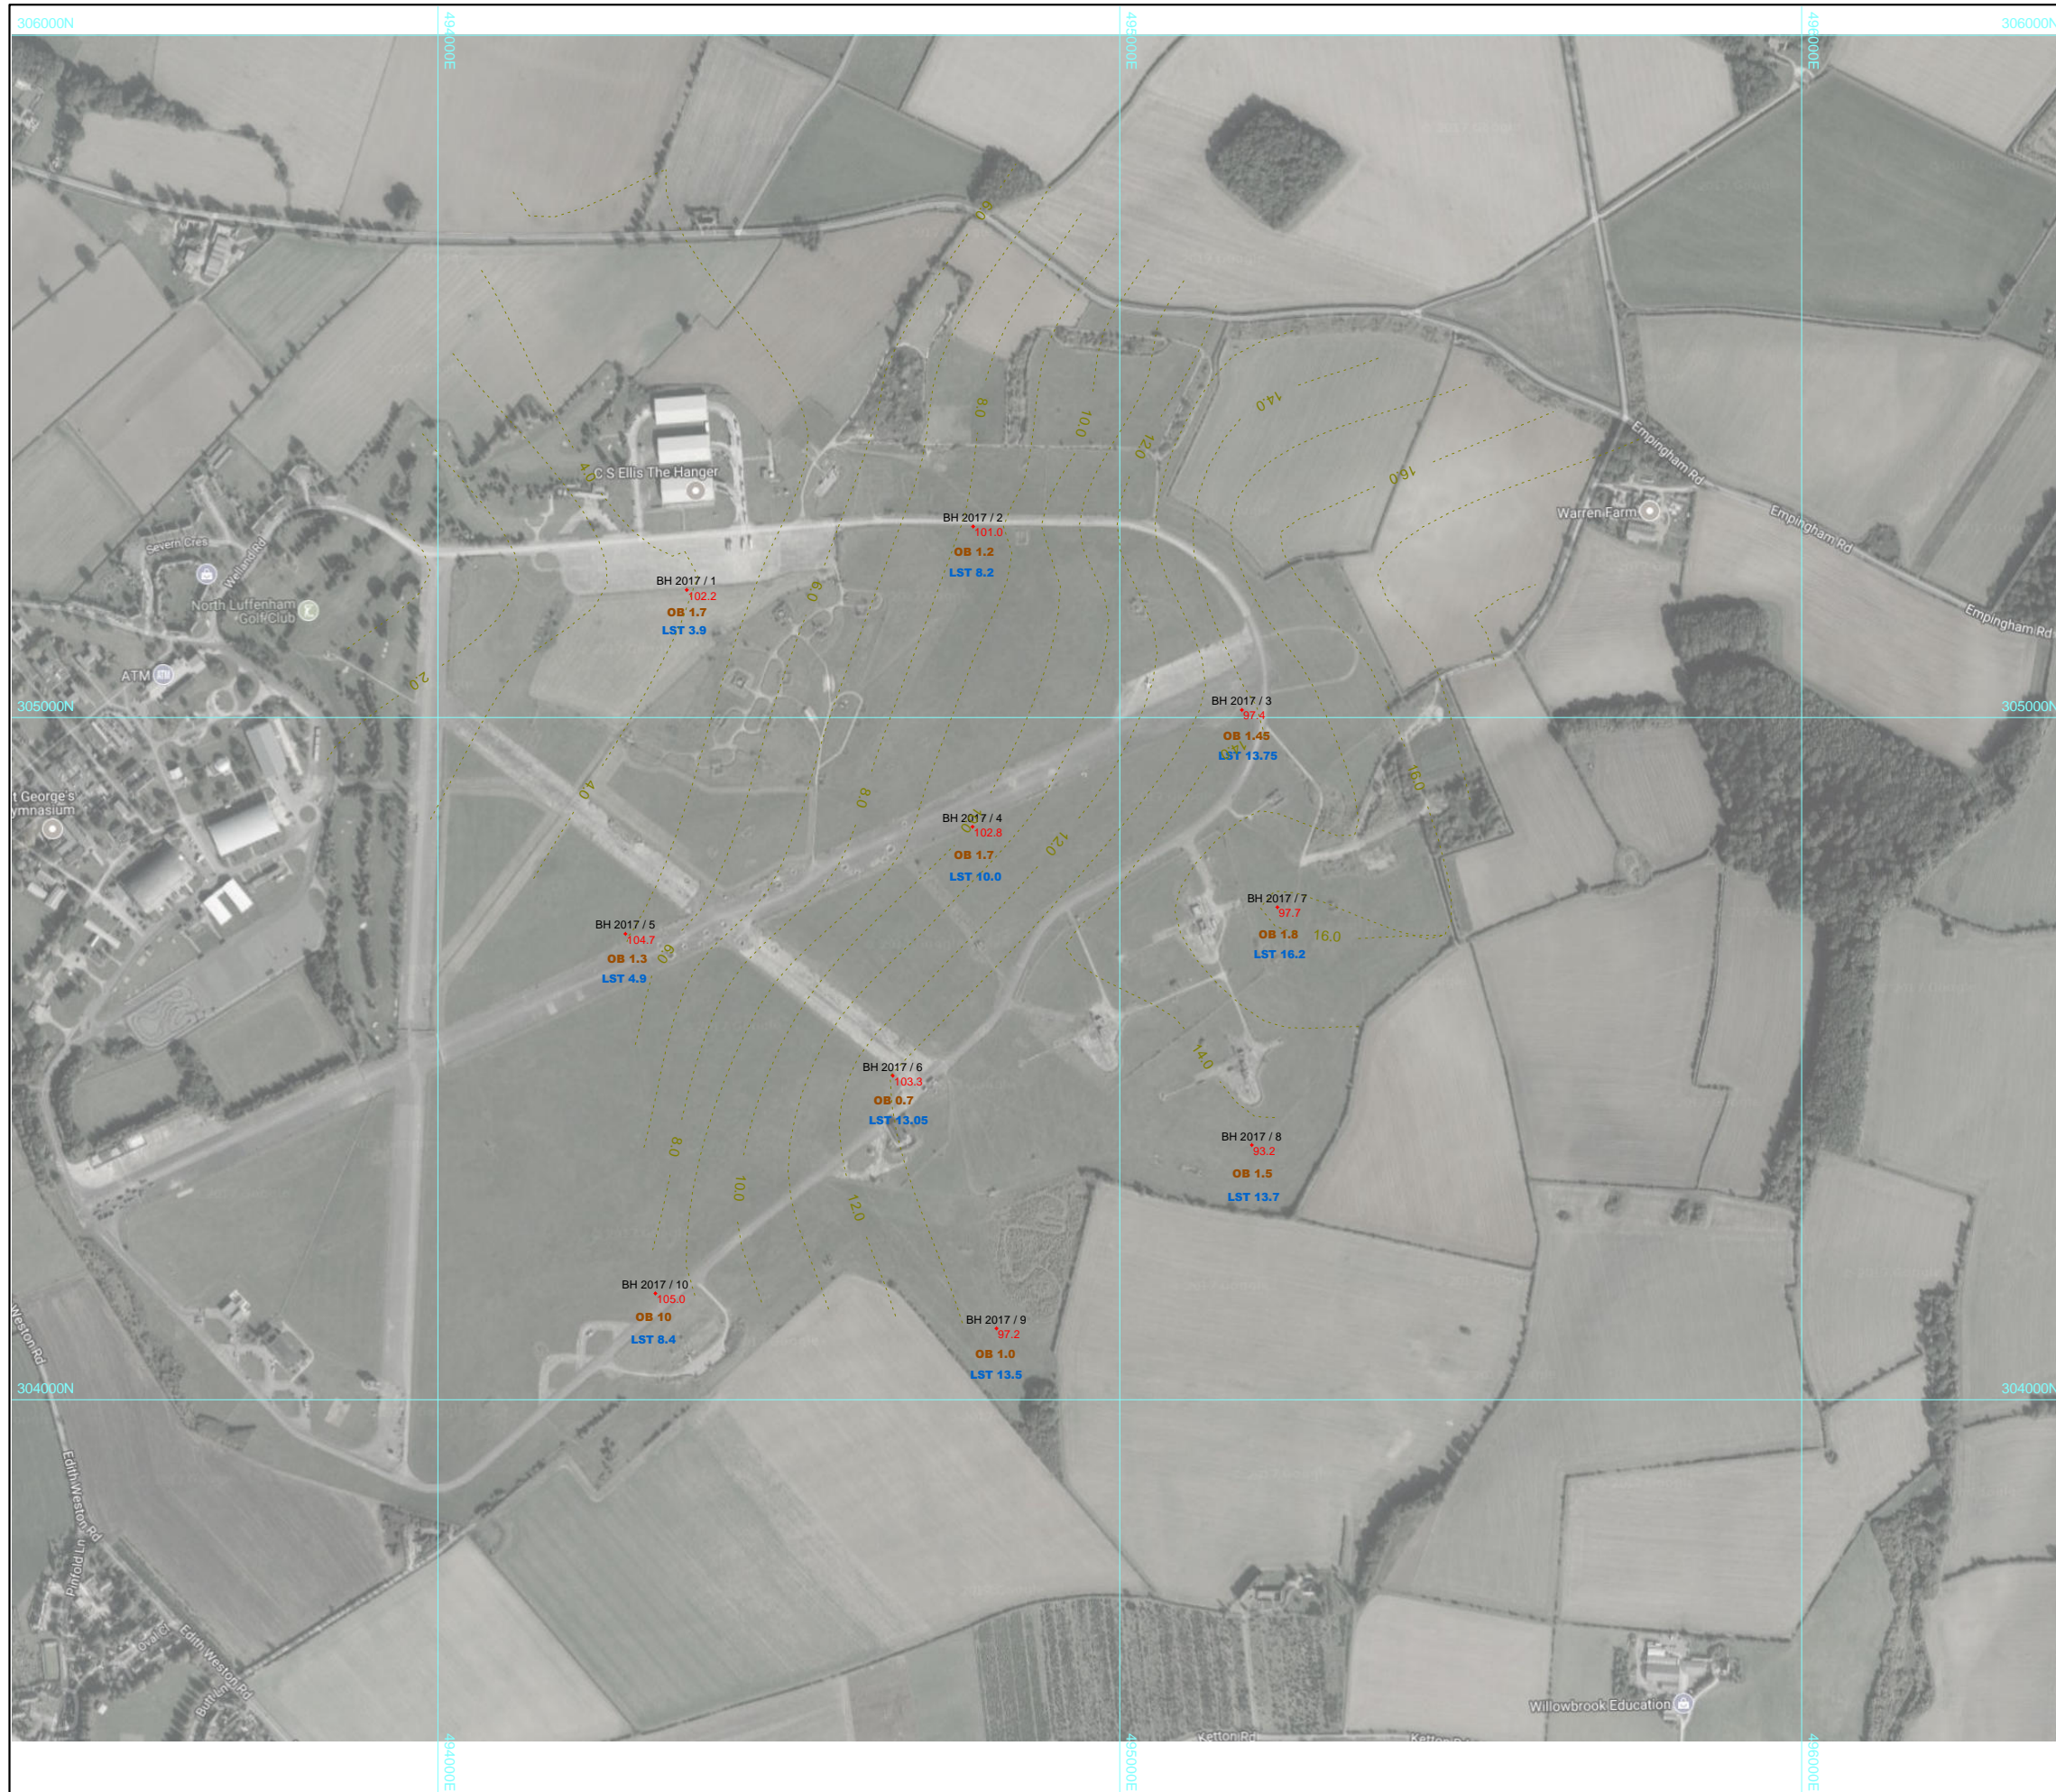
Drawing Name:
**Summary Geology Plan
 with limestone thickness isopachs**

A site investigation comprising 10 cored boreholes (totalling c.150m) was designed and tendered, and Geobor-S core drilling, utilising a Fraste PL.G rig, was undertaken by Apex Drilling Ltd during December 2017. This was logged in early January 2018 by Evolution Geological, with the borehole logs presented at Appendix A. The results of the drilling are summarised below (and on plan EG-SGB-GSC-0118 in Appendix B).
